Fire in an intensive care unit: causes and strategies for prevention

Koravangattu Sankaran, MD, FRCPC, FCCM; Allan Roles, PEng, MBA; Gordon Kasian, MD, FRCPC

Case report

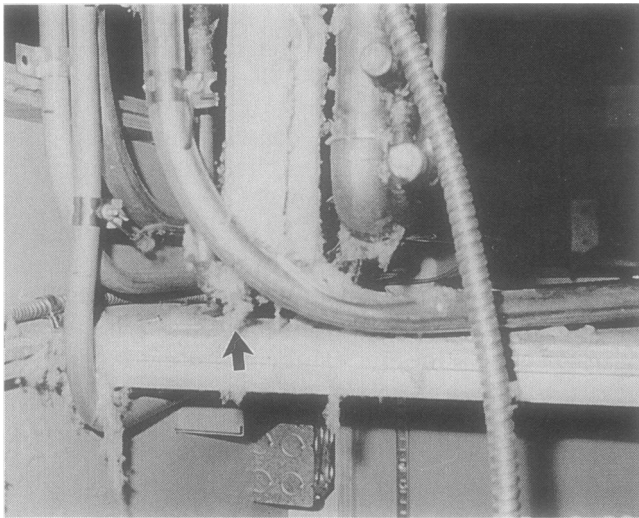
An incident had occurred several months before the fires that should have served as a warning signal. A curl of smoke had been noted from a socket on the chase and brought to the attention of the hospital maintenance staff. A significant collection of lint had been found in the socket, and so all sockets had been vacuumed. At the time it did not occur to anyone to check the inside of the sealed cabinets or the inside of the chase for lint accumulation (Fig. 1).

Fig. 1: Opened cabinets and chase, showing extensive accumulation of lint (arrow).

The renovation of our NICU took into account the factors that contributed to the fires. The cabinets are no longer sealed and are left open to the ambient air from underneath to ensure that no streaming occurs. This design allows lint and spilled materials to be cleaned up. The electrical sockets are now above rather than below the oxygen outlets.

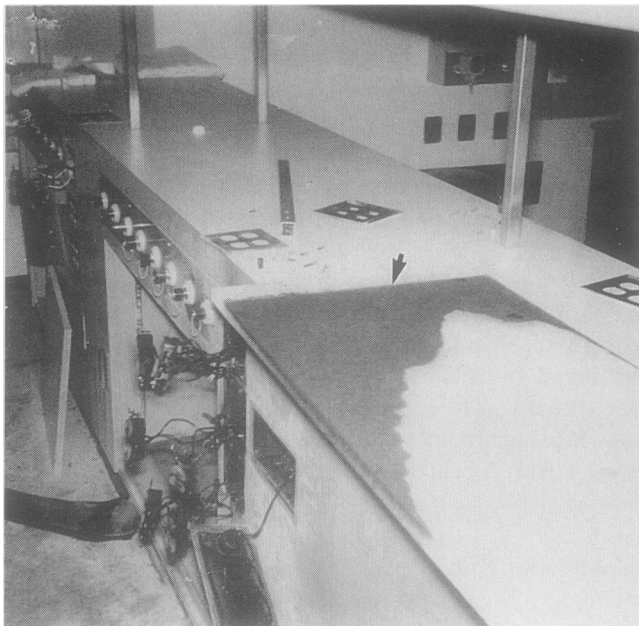
Fig. 2: Arrow indicates burn pattern on top surface of bottom slab of cabinet.

After the evacuation the cabinets were opened. There was not only severe damage near the top of each cabinet — where the fire started — but also intense charring on the top surface of the bottom slab (Fig. 2) and even on the linoleum floor on which the cabinet sat. In addition, there was severe charring along the electrical fittings and conduits (Fig. 3). Since fires normally burn upward the burn pattern proved confusing for the investigators.

the bottom slab of the cabinet (Fig. 2) raised the possibility of chemical spillage. The hospital welding shop was quickly transformed into a laboratory. Cabinet replicas were made, and various chemical materials spilt into the cabinet to induce a fire. However, the pattern of damage could not be matched.

Fires normally burn upward; the burn pattern of our fires was downward. The slow streaming of oxygen-rich air into the sealed cabinet and the greater heaviness of oxygen compared with room air made it possible for the oxygen to gravitate to the bottom of the cabinet. When the lint caught fire it was fuelled by the oxygen and burned downward. Fortunately the oxygen was consumed before the high-pressure pipes could burst, thus preventing a major disaster.

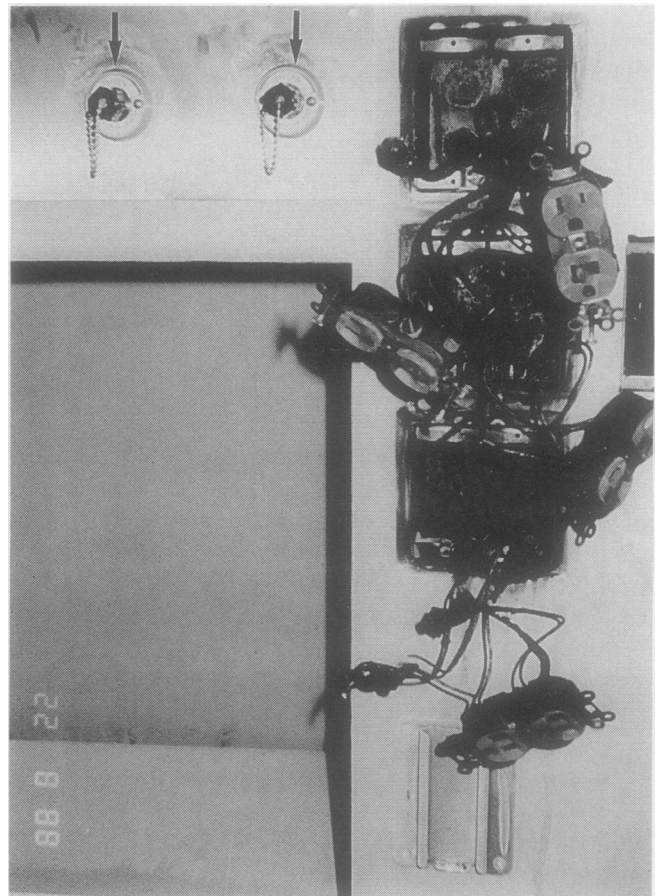
Fig. 3: Fire damage of electrical fittings. Arrows indicate oxygen outlets, which are located next to electrical outlets.

Finally, a multifactorial theory was proposed and tested. It was demonstrated that because of a pressure difference between the unit and the inside of the cabinets oxygen-rich air streamed through the electrical sockets into the cabinets. Between the first and second fires the air in the cabinets was checked and, indeed, found to contain more oxygen than normal atmospheric levels. Large quantities of free-flowing oxygen were used to run ventilators and resuscitation bags. Although tests revealed no leaks in the pipes the oxygen outlets leaked at the site where flow meters had been inserted. This leakage and the proximity of the oxygen outlets to the electrical outlets (Fig. 3) contributed to the streaming. In addition to oxygen the air flowing through the electrical sockets carried small amounts of lint, which accumulated inside the electrical boxes and the cabinets. When an isolette was unplugged a spark ignited the oxygen and lint, allowing the cabinet's otherwise relatively fire-resistant materials to burn easily until the oxygen was consumed.¹⁵ The introduction of oxygen-rich air and lint into the experimental cabinet reproduced the pattern of fire damage. A videotape of the recreated fire sequence is available from the Royal University Hospital.

There are no design-related safety codes specifying the location of oxygen outlets with respect to electrical sockets.¹⁶ We have reported the fires to the CSA and have suggested the development of standards for future hospital designs.
